# Manhole Inspection Summary

Manhole # S13QQ\_001MH

Insp Date: **9/25/07 11:37 AM**

**Location** Address: **REAR DAYCARE ON DUKELAND ST** Cross Street: **GWYNNS FALLS**

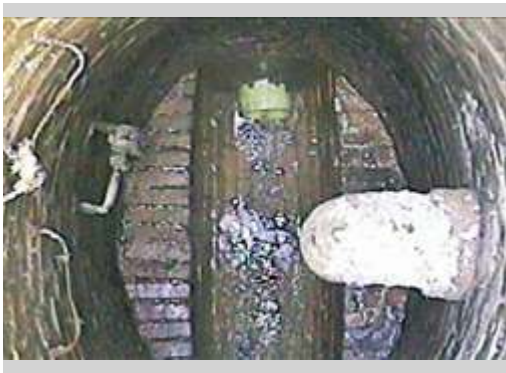
Top View

CORRODED RUNG

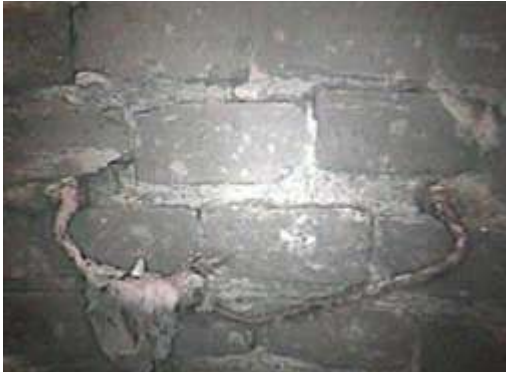
Defect 1

CORRODED RUNG

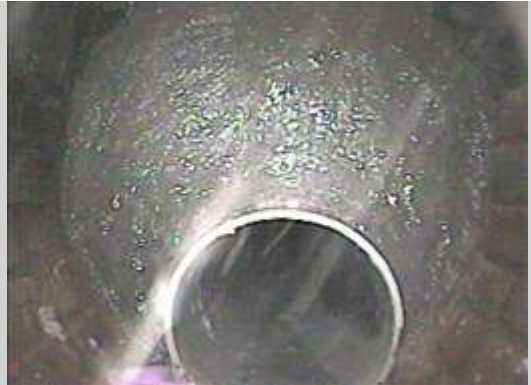
12 O'Clock Outflow

8 in. Circular Gravity Sewer  
Pipe Out @ 12 O'Clock

Pipe Height: (in.) Direct  
Pipe Material: **PVC** ☐ Pipe Lined  
Invert Depth: **10.88** (ft.) Flow Characteristics: **Slow**  
Deposits: ☒ None ☐ Mud ☐ Sludge ☐ Debris ☐ Grease  
Silt Depth: (in.) Deposits Extent:  
Infiltration: **None** Pipe Seal Cond: **Sound**

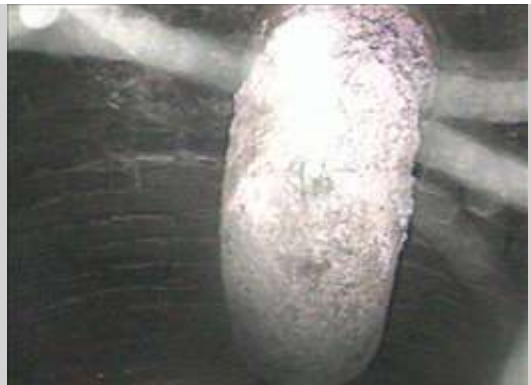
3 O'Clock Inflow

8 in. Circular Gravity Sewer  
Pipe In @ 3 O'Clock

Pipe Height: (in.) Direct  
Pipe Material: **DIP/CI** ☐ Pipe Lined  
Invert Depth: **6.53** (ft.) Flow Characteristics: **Slow**  
Deposits: ☒ None ☐ Mud ☐ Sludge ☐ Debris ☐ Grease  
Silt Depth: (in.) Deposits Extent:  
Infiltration: **None** Pipe Seal Cond: **Sound**

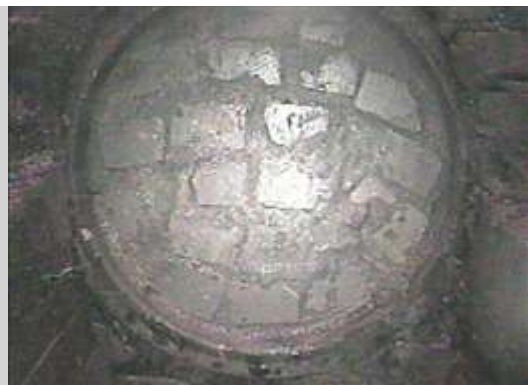
6 O'Clock Inflow

18 in. Circular Gravity Sewer  
Pipe In @ 6 O'Clock

Invert Depth: **10.53** (ft.) Flow Characteristics: **None**

Infiltration: **None** Pipe Seal Cond: **Unknown**
